# STRUCTURAL INSTABILITY IN THE BUILT ENVIRONMENT OF RIVERS STATE: A STUDY OF COLLAPSES AND CORRECTIONS

*Eze, Chijioke Nnamdi*

Department of Building Technology, Port  
Harcourt Polytechnic, Rumuola, Rivers State,  
Nigeria  
DOI:<https://doi.org/10.5281/zenodo.15461982>

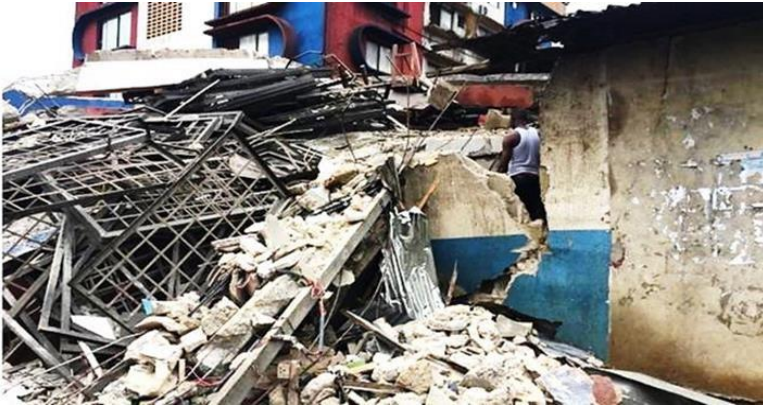
Fig 1.0: Collapsed school building at Rumubiakani

Similarly, Okah (2021) in the investigation of the collapsed 4-story building belonging to Immanuel High School Rumubiakani, Port Harcourt identified foundation failure as the cause of the collapse. He noted that the BC of  $108.80\text{KN/m}^2$  was inadequate for the shallow foundation, hence recommended pile foundation to terminate at 25m pile stratum.
