# IMPLEMENTING A RESIDENTIAL CONSTRUCTION QUALITY FRAMEWORK IN THE SOUTH AFRICAN BUILT ENVIRONMENT

Department of Civil Engineering,  
University of Johannesburg, Doornfontein  
Campus, Johannesburg, South Africa  
DOI: <https://doi.org/10.5281/zenodo.16810984>

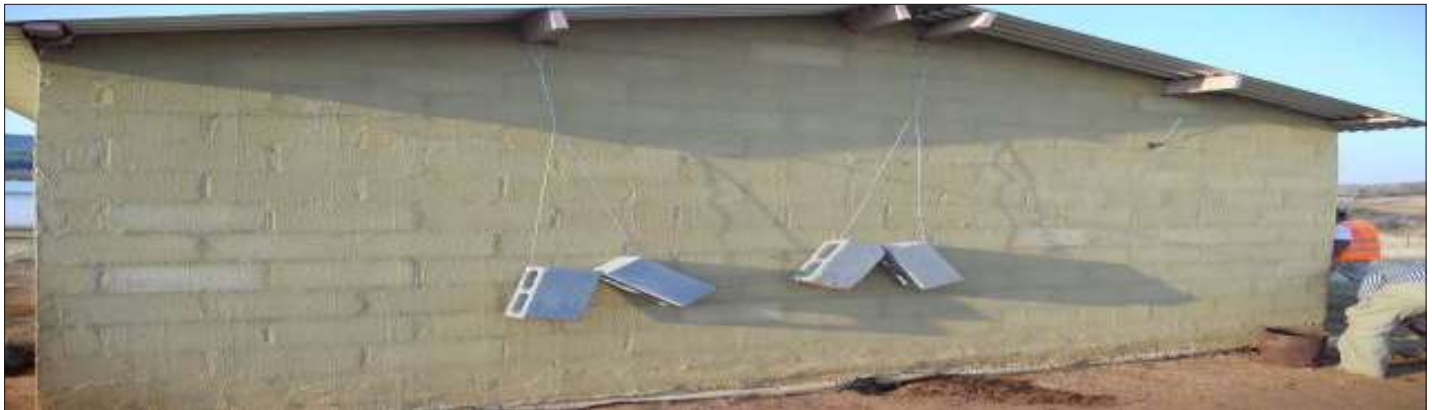
**Figure 4** : Typical roof anchoring system used for low-income houses

Of further interest to observe is the comparison of the quality of building elements of the houses. The building elements and the sub-elements associated with these elements were defined in Figure 2 and Table 2. Each building element has a score, and when aggregated with other elements, it gives an overall score for the house. For the low-income houses, the average quality score for the roofs and walls was 55% and 65%, respectively. This was not surprising, as most of the corrugated (IBR) roof sheets commonly used for low-income houses were torn, and as a result, the roofs were leaking within six months. Some of the roofs had boulders on top to prevent them from wind uplift, or cement blocks were used to

Anchor the roof beams (see Figure 4).

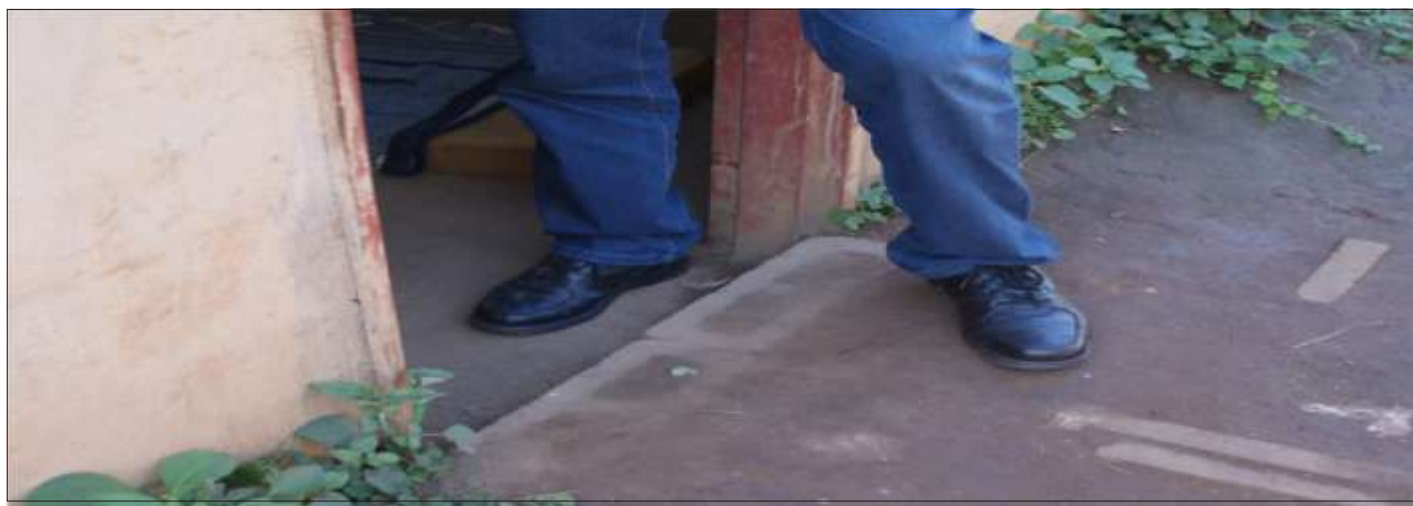
Figure 7: Example of poor substructure in low-income houses

poor sub-structure (floor) construction. The image shows that the floor level does not meet the minimum standard, which stipulates that the floor level must be at least 150 mm above the natural ground level. In the event of rain, the house is likely to flood, compromising the integrity of the foundation, the house, as well as the health and safety conditions of the occupants. Therefore, a developmental strategy for this homebuilder would be on the basic understanding of the impact of storm water on top structure performance. A similar comparison of walls and roofs for the same project suggests that the relative construction qualities of both elements are of a similar order
